Old Street

Three Tier Assessments

Tier 3 – 26.06.19

All Inclusive Cycling
and Walking at
Roadworks Report

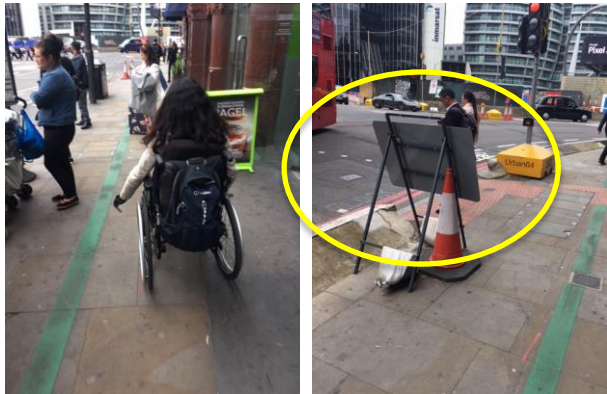
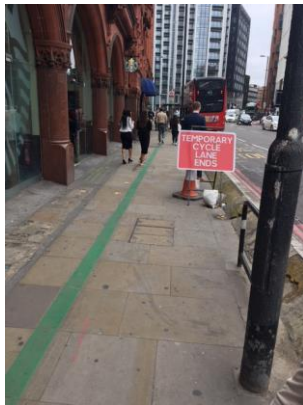
Observations and suggestions	City Rd north (both sides)
<ul style="list-style-type: none"> First noticeable barriers were the number of obstructions eg signs and advertising boards Wheelchair user tends to walk adjacent to the shopfronts as the footway is flattest and easiest to use Visually impaired person does not pick up the back of signs (yellow circle) due to lack of contrast. The cone assists but there is still an overhang which may be in conflict when walking passed. Remove sign (temp cycle lane ends) there are no temp lanes from both exits (Old St west to City Rd north is an advisory lane & Old St east - no markings from cycle filter lane before lights) Alternatively, reduce size of sign and erect on the adjacent lighting column

to increase footway capacity.

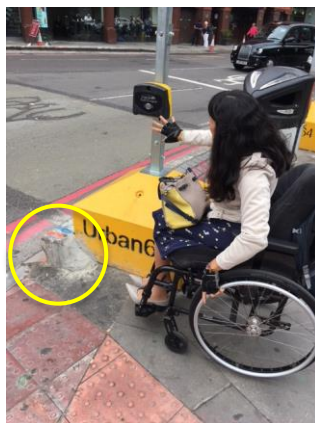
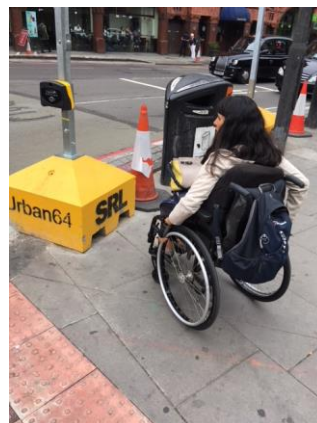
- The push button should be approx. 500mm (centre of pole to the tactile). A visually impaired/blind person would need to stand closer to the button which may mean one foot off the tactile. There is a raised trief section (yellow circle) and could be a trip hazard with this scenario.
- Wheelchair user needs to make more effort & manoeuvres to access the button.
- **Remove trip hazard and relocate unit closer to the tactile.**

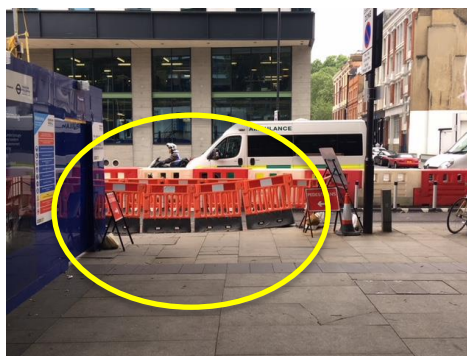
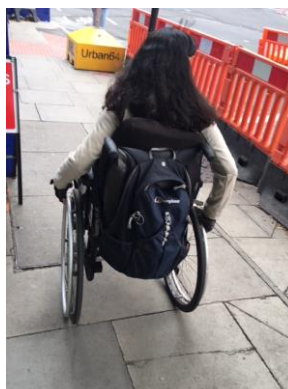
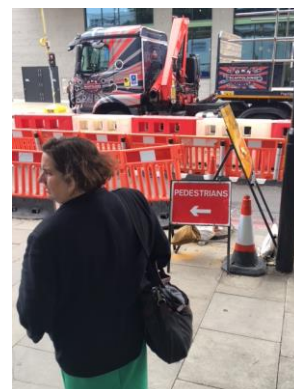
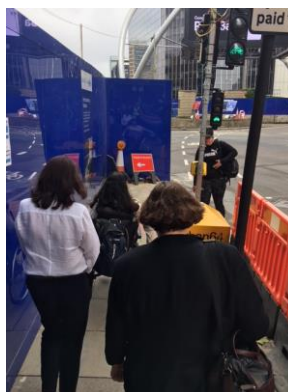
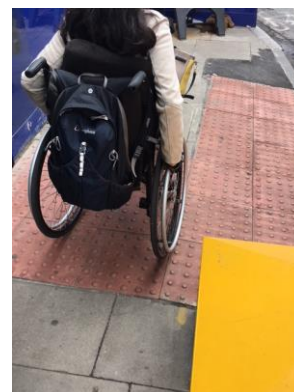
Old St west (north side)

- Visually impaired persons explained this area (yellow circle) looked like a closed section of footway and they would avoid approaching.
- Wheelchair user said she would not be confident that there is an accessible method to cross due to lack of visibility
- **Supply signs with adequate contrast, pull back hoarding to improve capacity, comfort and visibility (sec 17 also comes into effect eg hiding spaces etc)**
- There is a steep incline and if other pedestrians do not give way could mean wheelchair user is forced to use that section of footway and could fall out of her wheelchair.
- There is limited space to access crossing
- **Liaise with TfL engineering and Moorfields/RNIB to be advised on adequate signage type that can assist**
- Wheelchair user explained the discomfort and difficulty she has negotiating tactile paving and does not like to wait on the lead in. She

<p>asked why there aren't push button units both sides</p> <ul style="list-style-type: none"> Consider push buttons on both sides. 	
Observations and suggestions	City Rd south (both sides)
<ul style="list-style-type: none"> Very narrow section of footway. Some of the barriers were not flush to the trief kerb. MB pushed them in during the walk Maintain regular checks of width obstructions Hoarding location has caused on blockage point when someone is waiting at the push button Wheelchair user has to re-manoeuve herself to keep the area clear fro passing pedestrians. A visually impaired or blind person may not be aware of the situation Discuss issue with developer to see if hoarding can be pulled back Tactile area in poor condition (loose, raised parts) which is a trip hazard for visually impaired people. Wheelchair user struggled to negotiate the surface. Visually impaired attendees struggled to understand the message the black and yellow sign was supplying and were unable to see signs that showed footway closed and diversion.

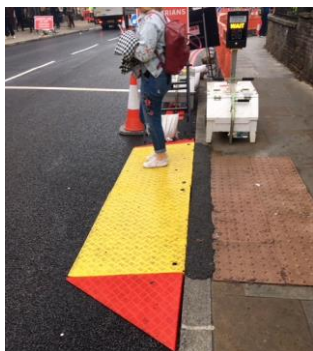
- Wheelchair user was not confident to use the diversion route as it was using the road and she may not be able to get back on the footway
- Visually impaired person mentioned ramp was not clear and the red and white signs blend in with red and white background.
- Investigate signage messages and how to be clear e.g. larger with more contrast and diversion signs stating 'accessible ramps each end'
- Wheelchair user found the gradient too steep and the double red lines uncomfortable to negotiate.

1. Extend ramp to cover double red which will supply gentle slope. Put water filled to the side to avoid access issues
2. Remove asphalt and replace with NAL ramp as per below.

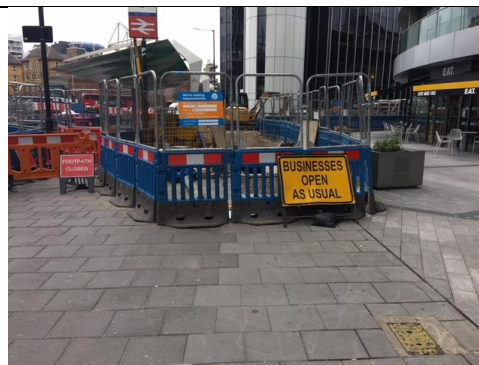
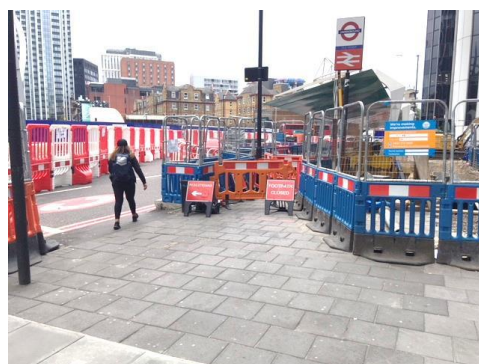
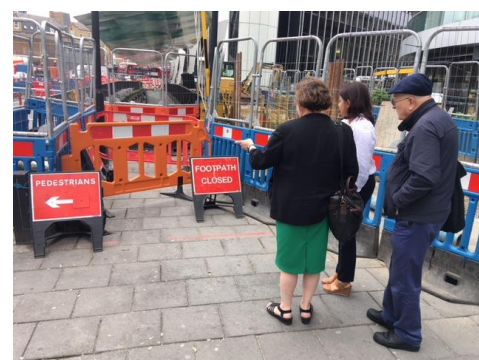
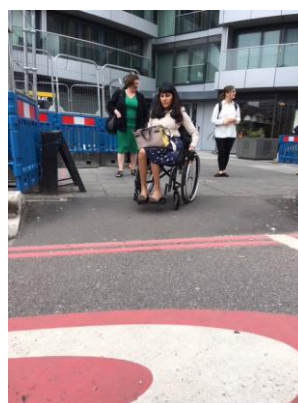
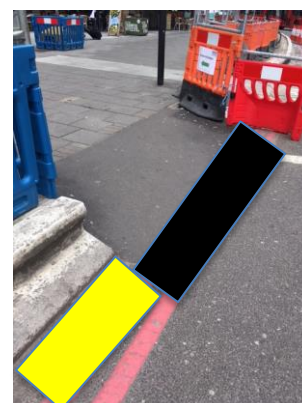
- A4 signs (yellow circle) cannot be easily seen by Angela and Sabina

- Visually impaired person suggested underground symbol is preferred and to supply more contrast

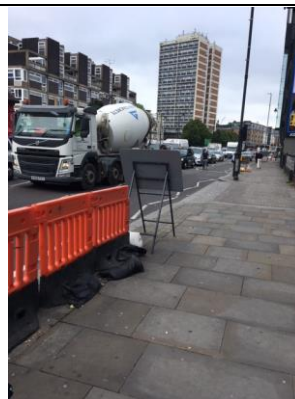
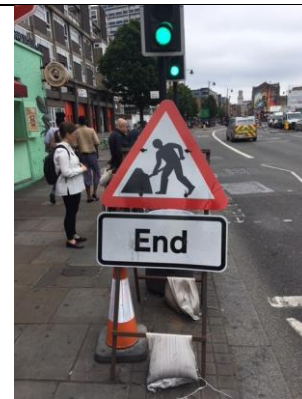
Observations and suggestions	Old St east (both sides)
<ul style="list-style-type: none"> • Visually impaired person highlighted that sign blends in with carriageway and there is no cone in place. • Road works end sign is high and blocks visibility of people waiting to cross • Add contrast measures to warning

- Cycle lane ends causing obstruction and leaning very close to carriageway.
- Is this needed as cyclists are now in a bus lane? Alternatively, reduce size and erect on nearest column

sign and relocate end of roadworks sign between columns after side road.

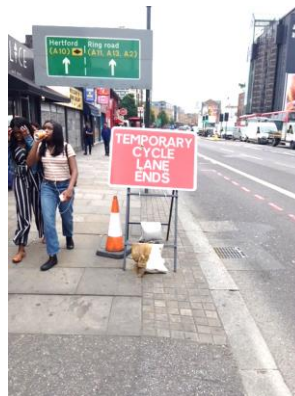
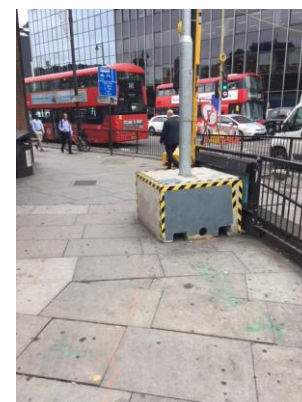
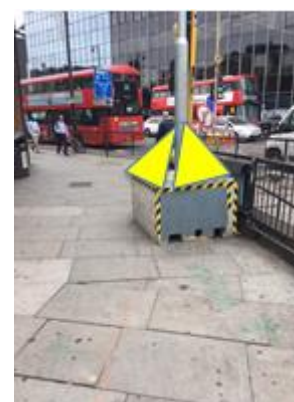
- Base of column block is flat which often leads to litter being left on the top
- (sec 17 comes into effect e.g. opportunity for glass bottles to be used as a weapon or missile).
- Suggest a cap using ply type material to remove opportunity
