# SITE 85855 – CLUGSTON CONSTRUCTION – WILTON ENERGY FROM WASTE PLANT

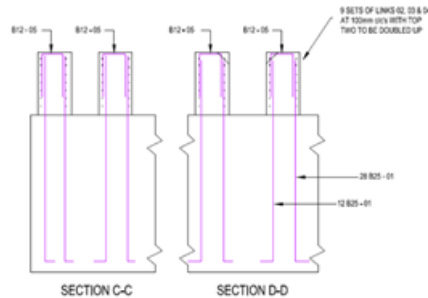
Due to the turn key nature of the project it was necessary for the civil work to be substantially complete before the design for superstructure and associated fixing details had commenced. Therefore the design called for over 900 rebates at almost, 1m deep, as image 1. These would later need to be roughened to create a mechanical bond with the sequential fill.

Image 1, sections through standard rebate details (size; 450x550 x850 deep)

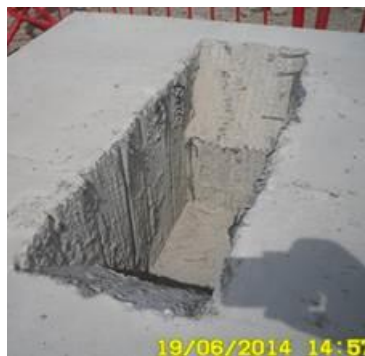
In order to entirely eliminate the exposure of our operatives to the hand arm vibration caused by using traditional methods of roughening concrete, the site team explored various techniques leading to us designing and producing prefabricated pocket forms, constructed from expanded metal sheeting with temporary formwork inside, that could be inserted into the plinth prior to concrete placement; with the only the internal sheeting to be removed post pour. As attached image 2.

Image 2, bolt pocket after pouring concrete and removing temporary form.

The bespoke rebate forms resulted in 250 man-days of 'hand arm vibration' totally eliminated.

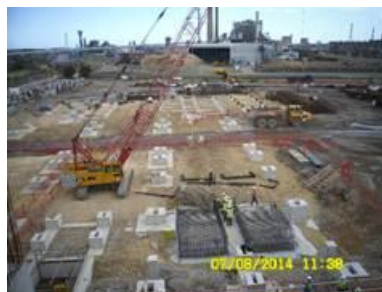
Images 3 and 4, showing some areas of plinths after construction

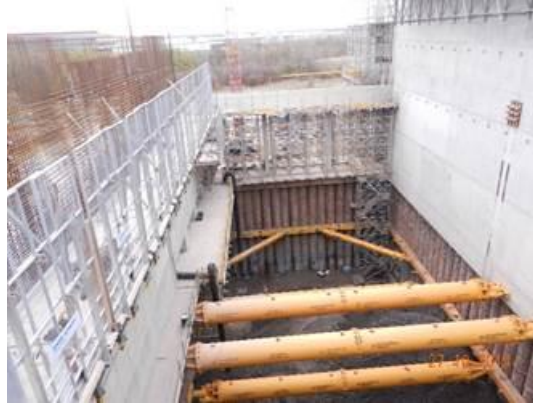
Secondly; due to growing industry demands driving optimisation of programming, it was necessary to construct the upper walls and cofferdam restraint beam of the 44x20x32m deep bunker before constructing the lower walls, as shown in image 5 below.

Image 5, showing walls above ground progressing prior to lower wall commencement

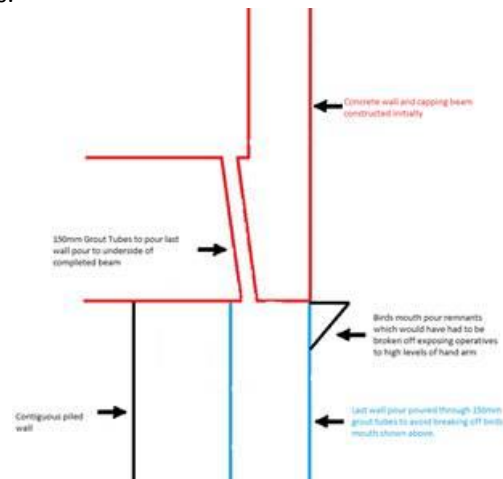
The common practice for placing concrete to the underside of an existing structure is to construct a bird's mouth with formwork, allowing the concrete to be placed, but leaving a relatively large concrete wedge to remove after striking the formwork, as shown in the sketch below. The resulting wedge removal and making good required demands the use of an array of power tools exposing operatives to high level of hand arm vibration, noise and dust risks.

To eliminate the exposure to the aforementioned risks the site team engineered the solution of pouring through the 2.5m deep concrete beam. To facilitate this 150mm grout tubes were inserted at 900mm centres around the 130m circumference of the capping beam to make it possible to pour the wall without the need for the offending birds mouth to the formwork.

The design team were reluctant to put such development into practice due to the high loads exerted on the beam by the walls above which are up to 1m thick and over 20m high. But through the continual commitment of the site team to the wellbeing of their employees, the aforementioned detail was achieved. In practice it was a complete success, eliminating around 20 man days of exposure to HAV's equipment.
