## Project: Northern Line Extension – Kennington

### KENNINGTON TUNNELS AND STEP PLATE JUNCTION

## TUNNEL PLUGS

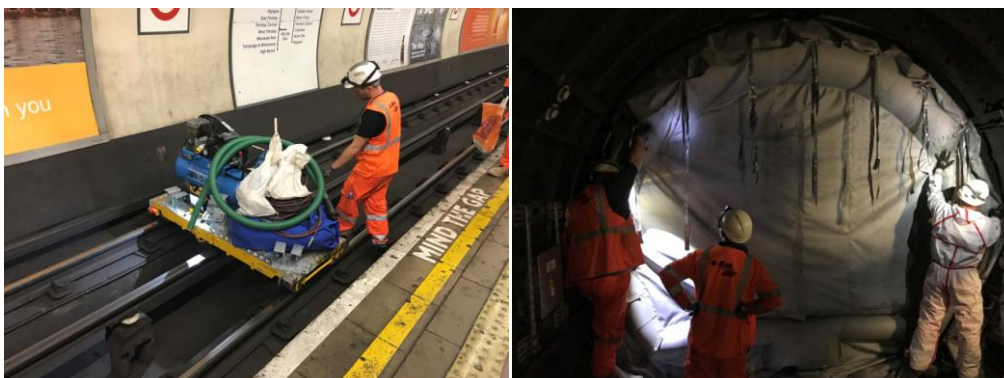
The tunnel plug was manufactured from a medium weight fibre glass fabric with a specially formulated aluminium pigmented and fire retardant polyurethane. The tunnel plug incorporated covers to the zips and a seal to the tunnel lining which prevented dust passing and provided a fire rated barrier.

The fixings between the tunnel plug and the tunnel lining were developed to allow the tunnel plug to move as the air pressure changed on the each side without compromising the dust / fire seal.

The completed tunnel plug was light enough to be lifted and installed by 2 persons. It could be transferred to track trolleys quickly and installed with ease to the fixings which were pre-installed in the tunnel lining.

The tunnel plug was installed and inflated in 20mins on the night of the works.

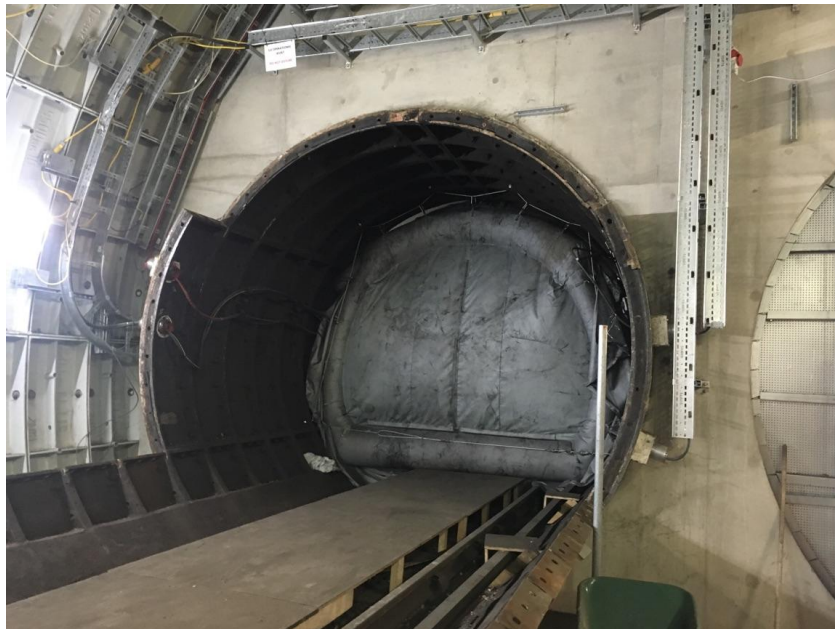
- The FLO team and their subcontractor 4Rail worked collaboratively to create the product. Team work was key to this innovative solution.
- A prototype was manufactured 10 weeks prior to the possession and was trialled during night shifts when trains were not running to ensure the fit with the existing tunnel was correct and that the information obtained during the 3D scanning was correctly applied to the manufacturing process.
- The team undertook trial installs to time how long it would take to move and install the tunnel plugs.
- A monitor and compressor were fitted to the tunnel plugs during the weekend works to ensure the air pressure was maintained. This system could automatically `top` up the air inside the plug as required to ensure the seal was not compromised.
