## **Temporary White Lining**

The M6 J16-19 SMP requires all current surface course to be replaced to a depth of 35mm -50mm. The work generates the need to put down temporary white lining when laying the new surface course, which when removed can cause surface damage. Also, there can be customer complaints regarding the state of temporary road markings through Smart Motorways roadworks due to ghosting caused when blacking out and removal of existing white lines

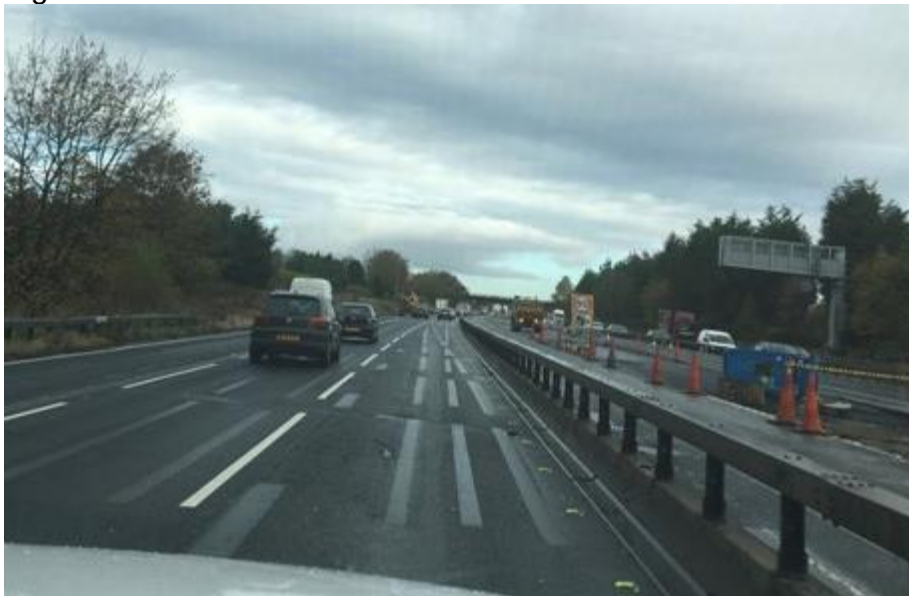
Fig 1

Traditionally lines are blacked out with an anti-skid paint. Over time the skid resistance wears off and the black lines are visible and confusing to the road user (Fig 1), particularly in low level sunlight or wet conditions.

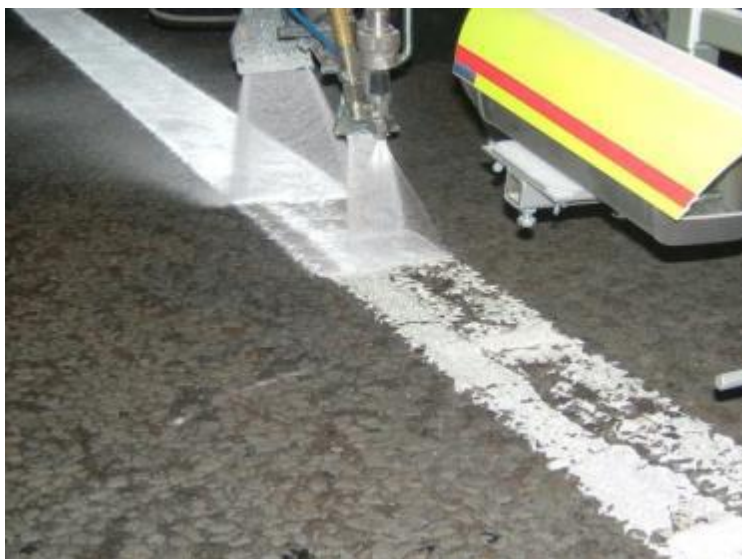
Fig 2

Initial trials conducted in the compound (Figs2proved successful with the white lines being removed after 3 weeks by using a high-pressure wash which caused no damage to the newly laid blacktop.

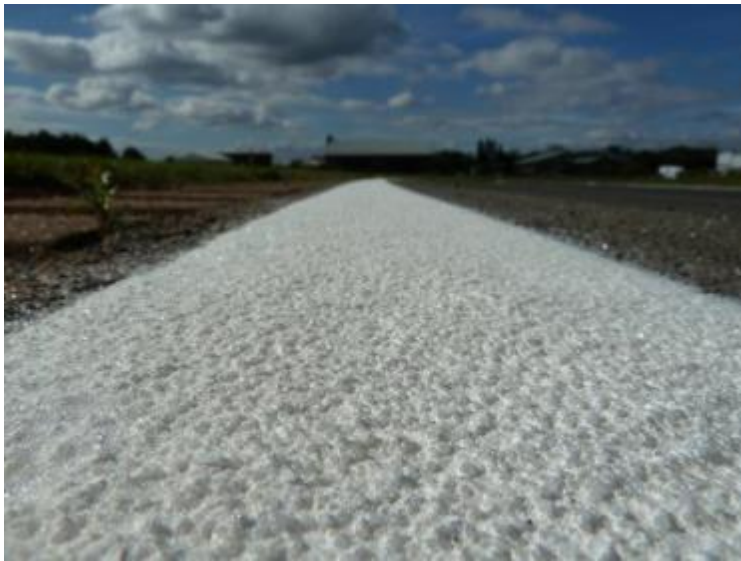
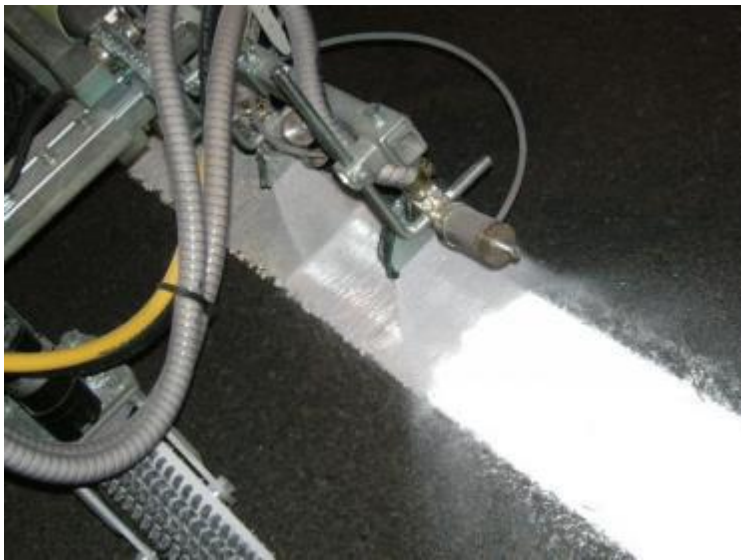
Fig 3

Following this trial in the compound, the Hyperline has been used extensively on the project (Fig 3) to provide a clear decisive lane marking for the travelling public, which in turn can be readily removed without leaving the legacy ghosting that has previously been the case.

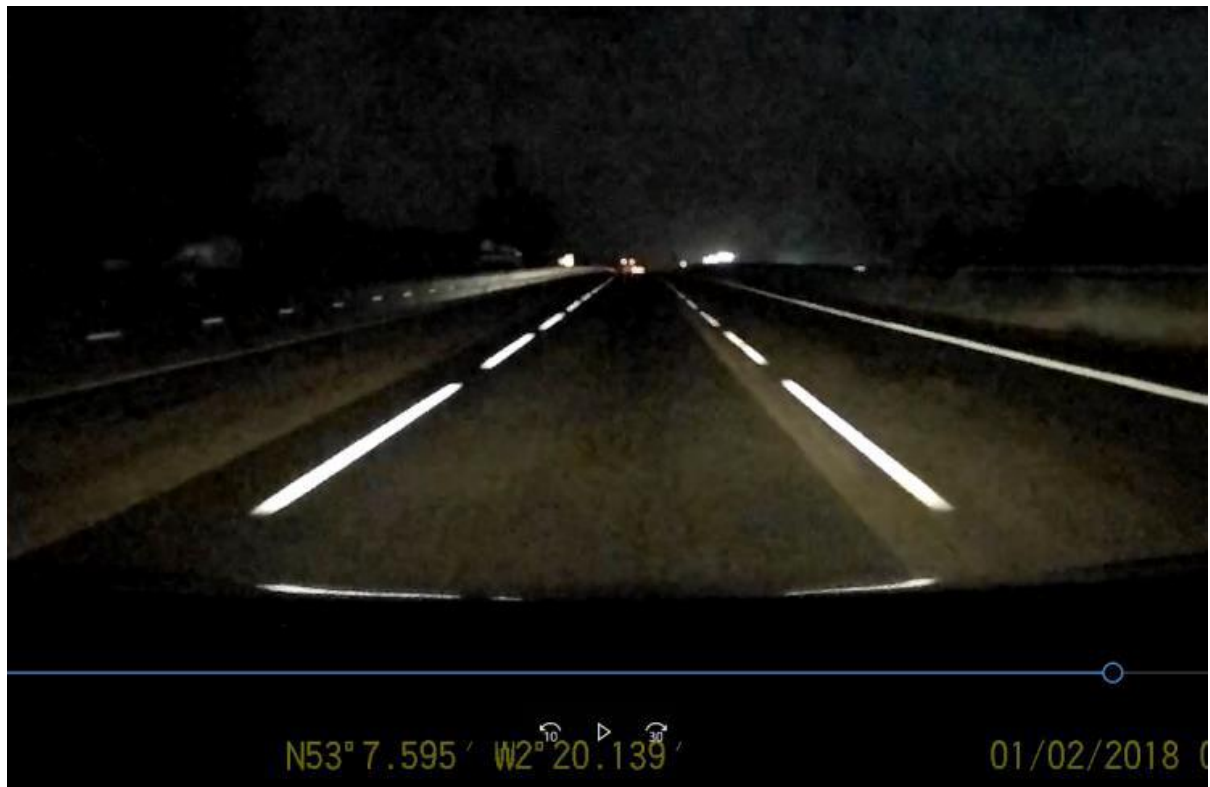
- Improved experience for the customer - Improved reflectivity, Fig 4 shows the markings on the M6 at night
- Less environmental impact as the product is solvent free with zero VOC's
- Reduces future maintenance or potentially further significant surfacing costs
