Old Street

Three Tier Assessments

Tier 3 – 26.06.19

All Inclusive Cycling
and Walking at
Roadworks Report

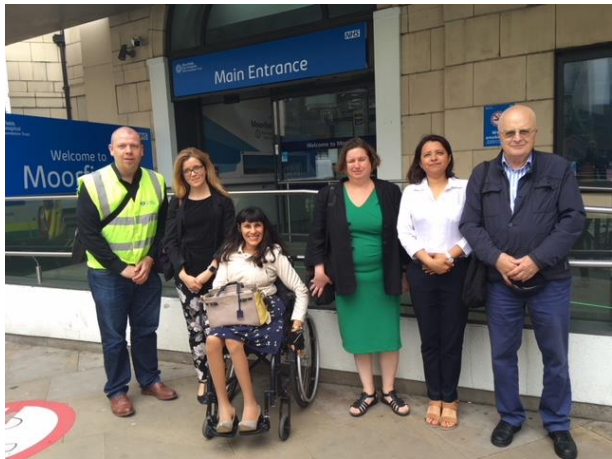
Group Comments	Site Pictures
<p>We all met at Moorfields Eye Hospital entrance. A safety brief and 3rd tier roadworks patrol introduction was supplied to the group. Outcomes - TfL require to better understand all the barriers the walk highlights so mitigation measures can be considered.</p> <p>Section 17 crime & disorder act – we have an obligation and duty of care to ‘Consider crime and disorder in all undertakings’</p>

Observations and suggestions	City Rd north (both sides)
<ul style="list-style-type: none"> First noticeable barriers were the number of obstructions eg signs and advertising boards Wheelchair user tends to walk adjacent to the shopfronts as the footway is flattest and easiest to use Visually impaired person does not pick up the back of signs (yellow circle) due to lack of contrast. The cone assists but there is still an overhang which may be in conflict when walking passed. Remove sign (temp cycle lane ends) there are no temp lanes from both exits (Old St west to City Rd north is an advisory lane & Old St east - no markings from cycle filter lane before lights) Alternatively, reduce size of sign and erect on the adjacent lighting column
